## Case 240 : Narrative

Case Vehicle (A): 2001 Ford
Type: F-350, 4x4, 4-door pickup
Driver: 28-year-old male
CDC: 12-FZEN-2

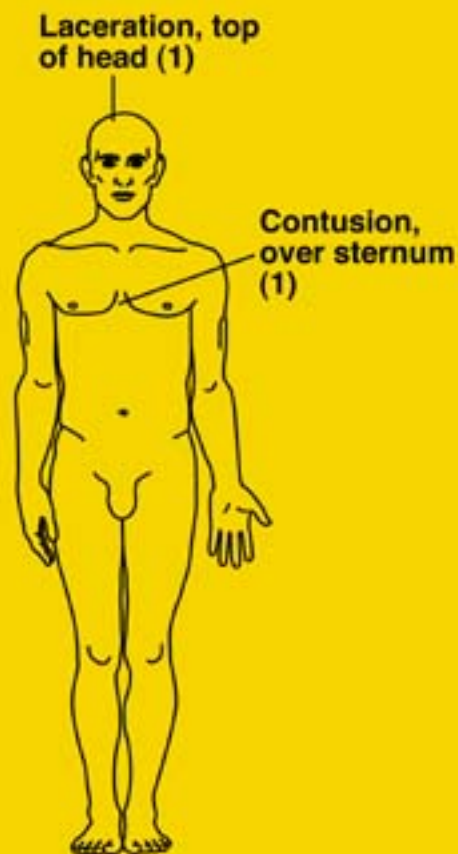
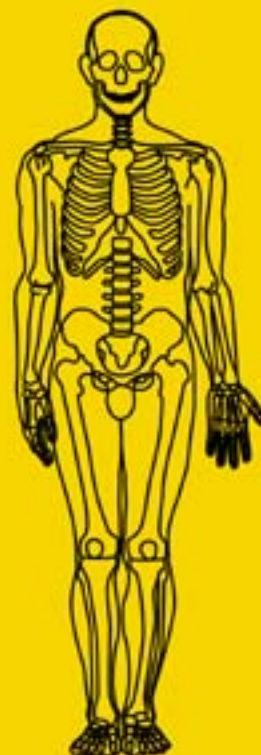
Occupant: Driver	Age: 28 years	Gender: Male		
Restraints: 3-point belt <u>not</u> worn; airbag deployed	Stature: 188 cm (6 ft, 2 in)	Mass: 86 kg (190 lb)		
Injury Description	A.I.S.	Injury Source		
—	—	Definite	Probable	Possible
Laceration, top of head	1	—	Sunvisor	—
Contusion, over sternum	1	—	Airbag	—
Maximum A.I.S. Level	1	—	—	—
Injury Severity Score	1	—	—	—

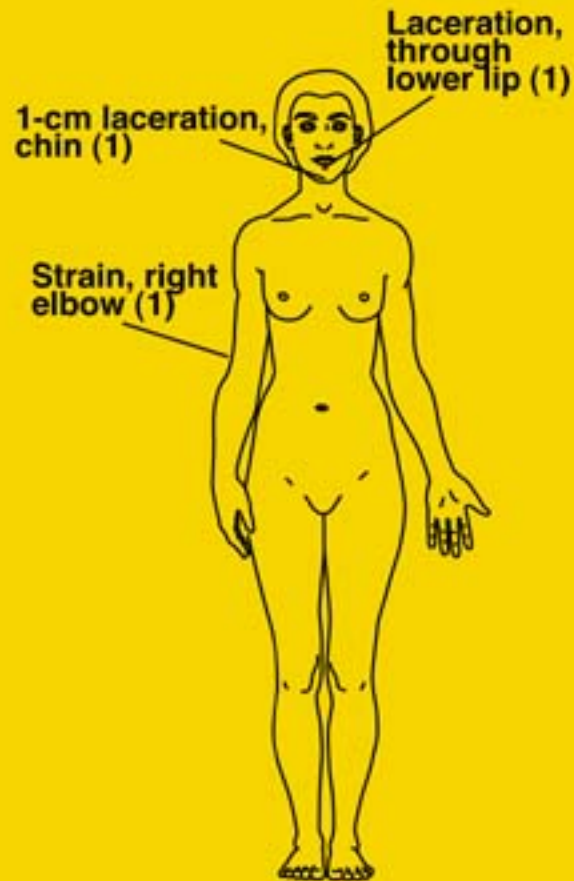
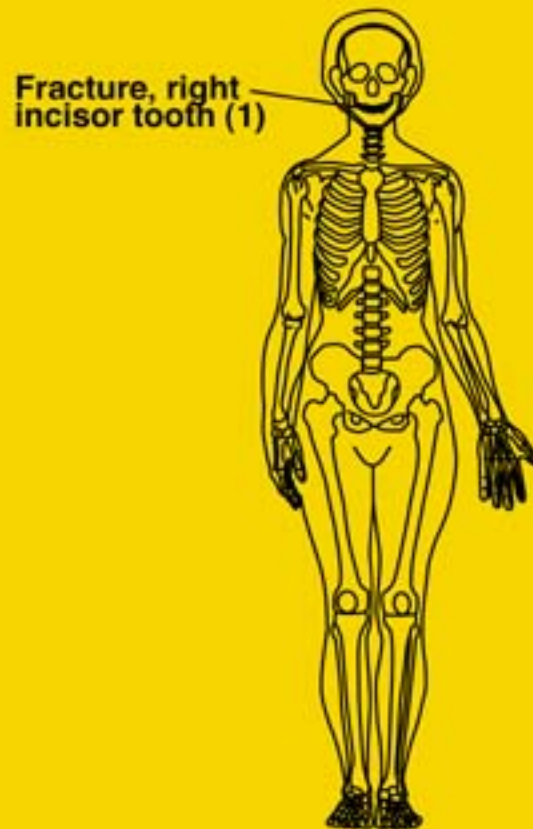
Occupant: Right front	Age: 23 years	Gender: Female		
Restraints: 3-point belt <u>not</u> worn; airbag deployed	Stature: 160 cm (5 ft, 3 in)	Mass: 48 kg (105 lb)		
Injury Description	A.I.S.	Injury Source		
—	—	Definite	Probable	Possible
1-cm Laceration, chin	1	—	Windshield	—
Laceration, through lower lip	1	—	Windshield	—
Fracture, right incisor tooth	1	—	Windshield	—
Strain, right elbow	1	—	—	Airbag
Maximum A.I.S. Level	1	—	—	—
Injury Severity Score	3	—	—	—

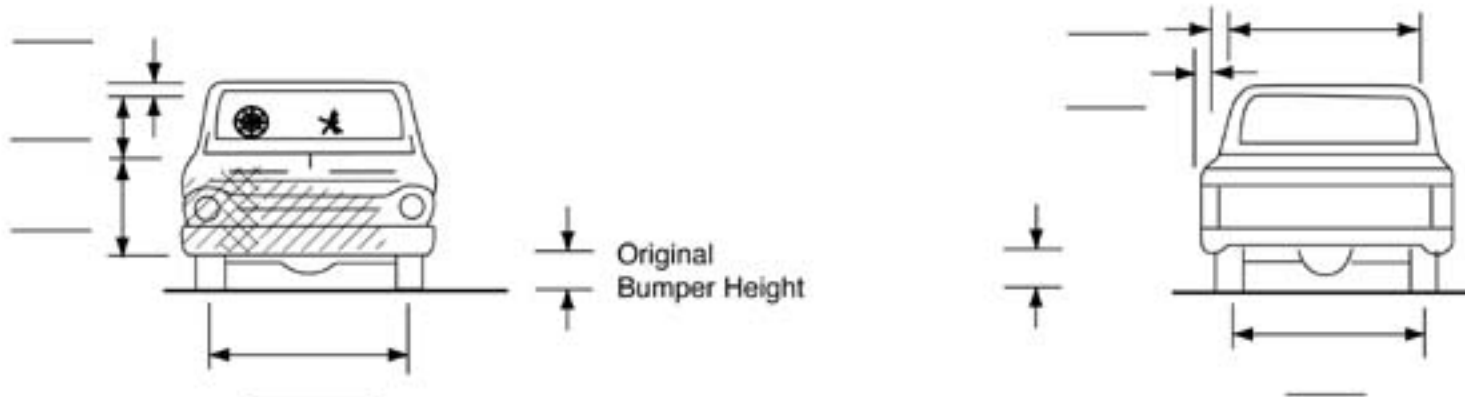
# MEASUREMENTS IN CENTIMETERS

**Direct damage length = 21 cm**  
**Max crush = 34 cm**

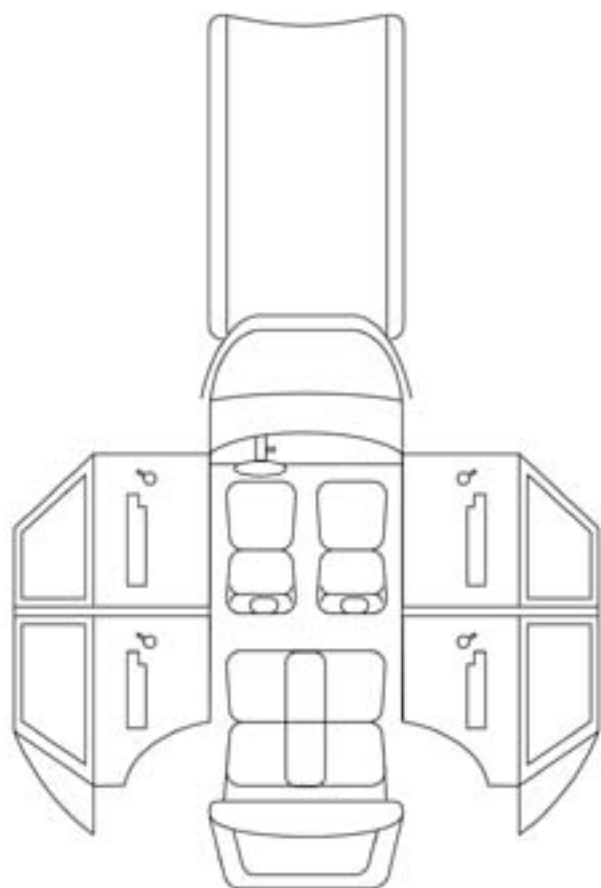
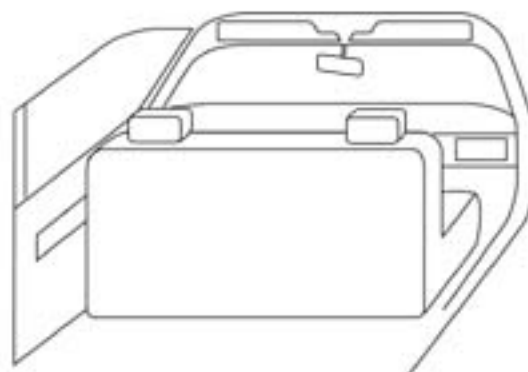
### OCCUPANT CONTACT WORKSHEET

Contact	Interior Component Contacted	Occupant No. if Known	Body Region if Known	Supporting Physical Evidence	Confidence Level of Contact Point
A	Windshield	1	Hand	Radial crack	3
B	Reaview mirror	1	Hand	Cracked	2
C	Sunvisor	1	Head	Pivot cover broken, scuff mark	1
D	Knee bolster	1	Knee	Scuff mark	1
E	Knee bolster	1	Knee	Crack	2
F	Windshield	2	Head	Spider web	1
G	Glove box	2	Knee	Scuff mark	
H					
I					
K

Pivoit cover broken, scuff mark

Cracked

Radial crack

Scuff mark
